Manhole Inspection Summary

Manhole # S29E__045MH

Insp Date: **9/6/07 7:55 AM**

Location Address: **701 LEXINGTON AVE**

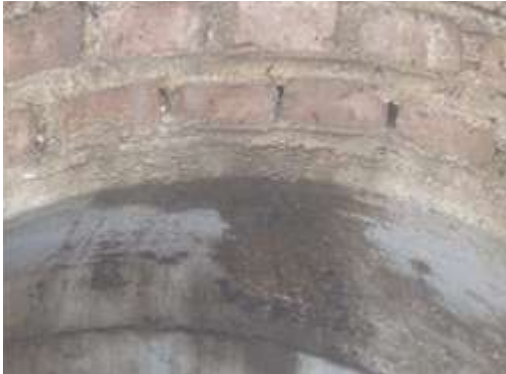
Defect 4

Infiltration: ☐ None ☒ **Joint** ☐ Cracks ☐ Mortar ☐ Roots ☐ Wall

CORBEL JOINT INFILTRATION

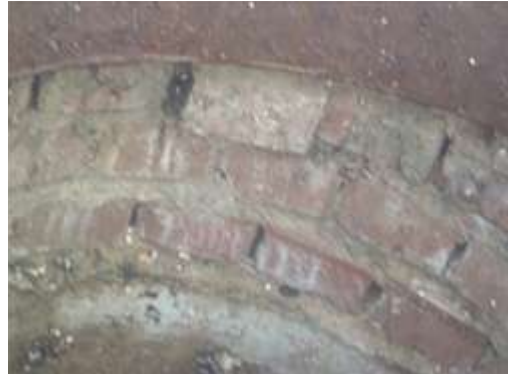
Defect 3

Condition: ☐ Sound ☐ Cracked ☐ Root Intrusion ☒ **Loose Brick** ☐ Deteriorated

LOOSE CORBEL BRICKS

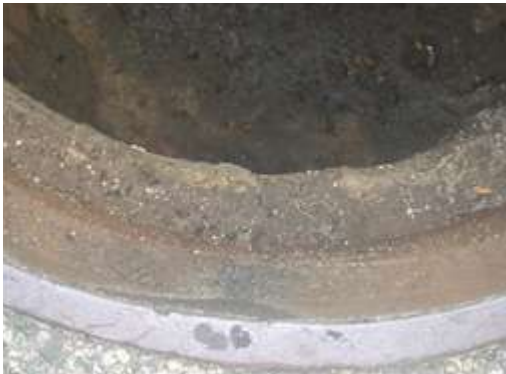
Defect 2

Offset: **2** (in.)

FRAME OFFSET

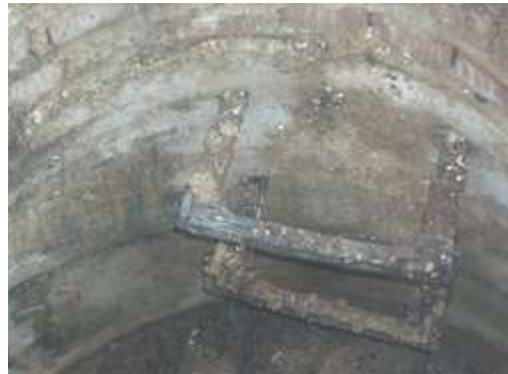
Defect 1

☒ **Evidence Of Surcharge** Depth: **2** (ft.) ☐ Active Surcharge Present

SURCHARGE EVIDENCE ON STEPS
AND WALL

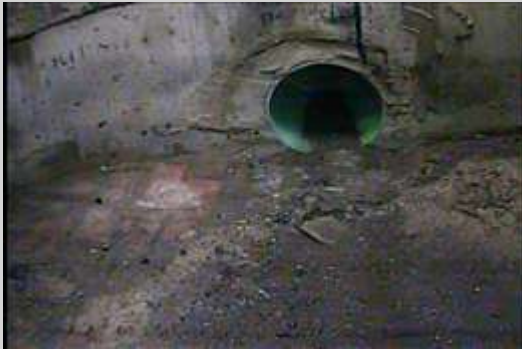
12 O'Clock Outflow

8 in. Circular Gravity Sewer
Pipe Out @ 12 O'Clock

Deposits: ☐ None ☐ Mud ☒ **Gravy** ☐ Debris ☐ Grease

Silt Depth: **1** (in.) Deposits Extent: **Light**
